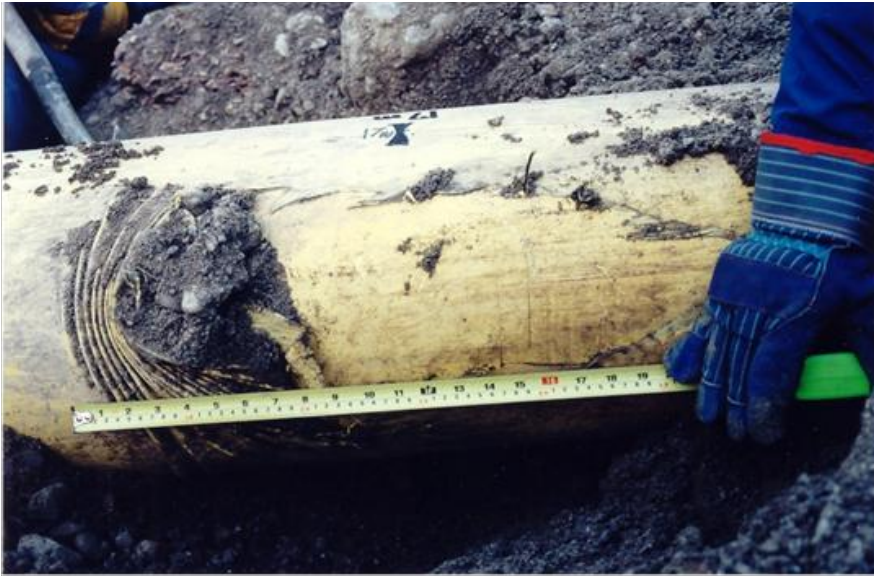
Figure 4.3 is a photograph of the effects of axial ground movement on a NPS 12 pipeline, which led to a small wrinkle in the pipe (Figure 4.4) but no loss of containment. The wrinkle was identified through in-line inspection (Figure 4.5). The photograph in Figure 4.3 shows how

Figure 4.3 Damage to coating on NPS 12 pile from soil movement.

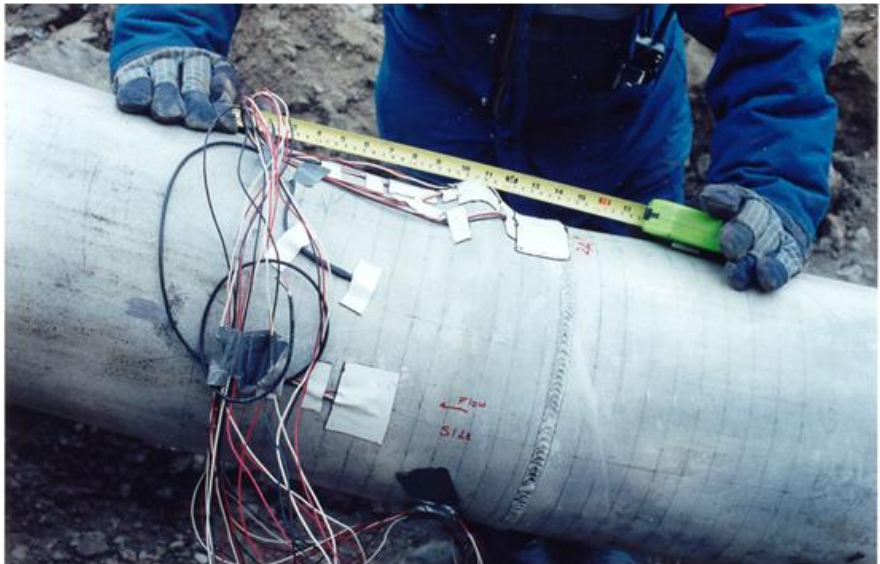
Figure 4.4 Wrinkle formed in NPS 12 pipeline due to soil movements.
